International High- Performance Built Environment Conference – A Sustainable Built Environment Conference 2016 Series (SBE16), iHBE 2016

The role of post occupation evaluation in achieving high performance buildings through diagnostics

Krishna Munsami[a*], Deo Prasad[a,b], Lan Ding[a]

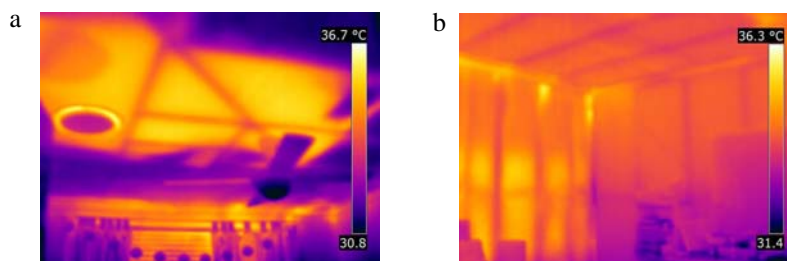
The thermal imaging Fig. 6 indicates poor quality of insulation management consistent in all homes, including walls and the ceilings. The thermal patterns on the ceiling and walls should be homogenous as designed and modelled with some minor changes within the ceiling joists and wall studs due to thermal breaks but in this instant, there are large inconsistencies. The temperature of the internal and external of the houses as recorded is listed in (Table 1). Temperature variations at the ceiling and walls ranged from a low 25.4^0C to a high of 41^0C.

The homes indicate that thermal irregularities are present on the walls and ceiling reducing the thermal performance of the building envelope. The areas of high thermal patterns are an indication of sub–standard practices in insulation management and in some areas, thermal breaks.

Fig. 6. (a) Thermal irregularities at ceiling; (b) Thermal irregularities at walls and ceiling.

This study indicates that all test homes have large heat gain through ceilings and some walls. Insulation in the attic space is critical as temperature can reach in excess 50^0C. All test homes have sub-standard quality of insulation within the ceiling space. The ceilings and some areas of the walls are producing increased levels of heat and performing as a radiant heater in the warm summer months. Areas of lighting, air-conditioning supply vents and exhaust fans have insulation removed and displaced. The thermal images also indicate greater heat transfer at the cornice of exterior walls. This is due to the insulation not crossing the top plate in the ceiling area but rather stops short, allowing greater heat transfer from the roof tiles to the wall plate which is transferring the heat to the cornice area.

Some walls in the test homes are of cladding observed in House 25 (Fig.6b). Insulation placed in the cladding walls seems to have the same R-Value of insulation as the brick-veneered area. Insulation placed within cladding walls should have higher R-Value to compensate for the increased heat transfer. Thermal bridges of the test homes are at minimal, mostly caused by the timber framing which may have a small impact on energy consumption. Reducing cluster studs by changing the design is an option in reducing thermal bridging.

Air-conditioning duct leaks within the attic space can have a significant impact on energy use. Thermal images of the ceiling indicate cold spots which may be related to duct leaks. This would require further research in establishing the level of tightness of the air-conditioning duct, and the impact on energy due to coolth loss.
